## Coal Combustion Waste Impoundment

### Task 3- Dam Assessment Report

*John E. Amos Plant (Site 26)*

*Fly Ash Dam Complex  
American Electric Power  
St. Albans, West Virginia*

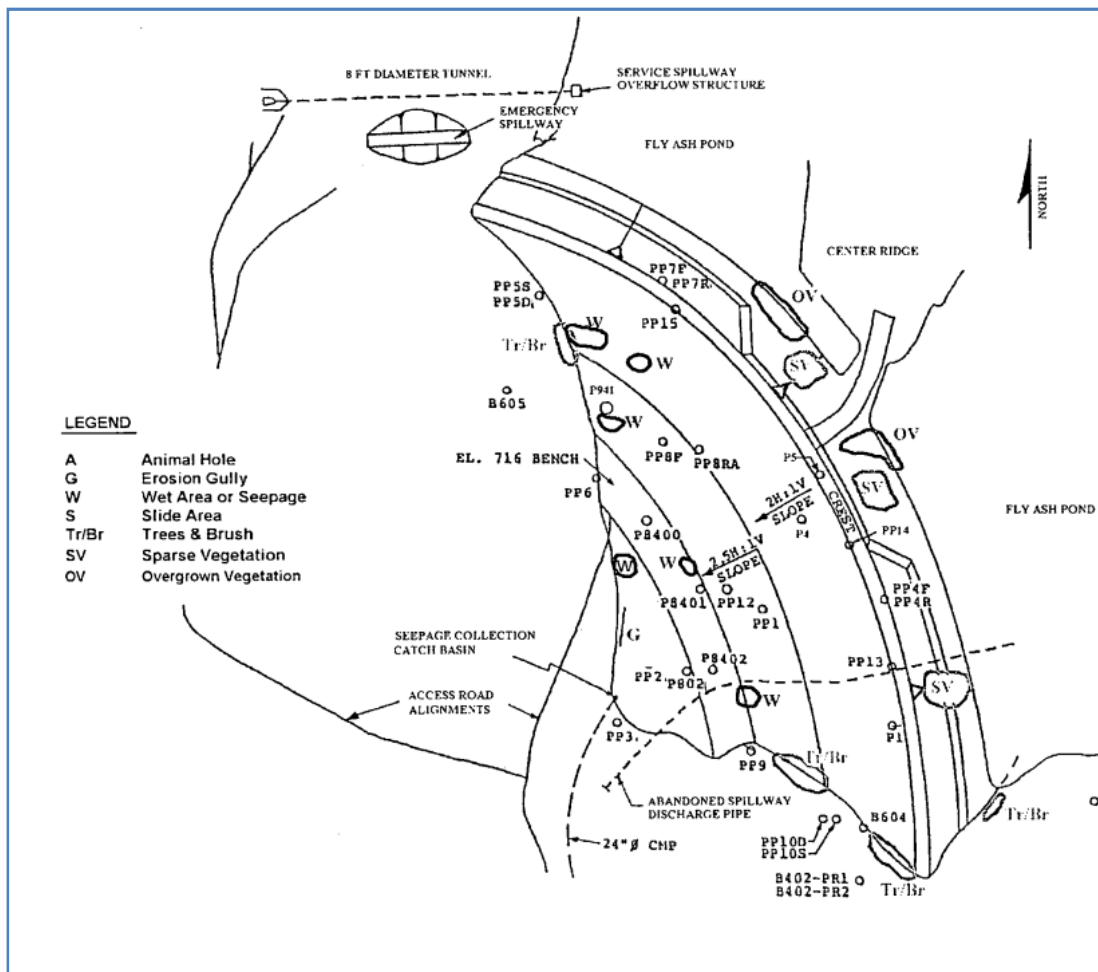
Figure 9.2.1-1- John Amos Fly Ash Pond Dam Configuration and Monitoring points.

Deformation monitoring data are available for 23 points on the dam: 15 points along the crest and eight points on the downstream face of the dam. The dam configuration and location of monitoring points are shown on Figure 9.2.1-1.

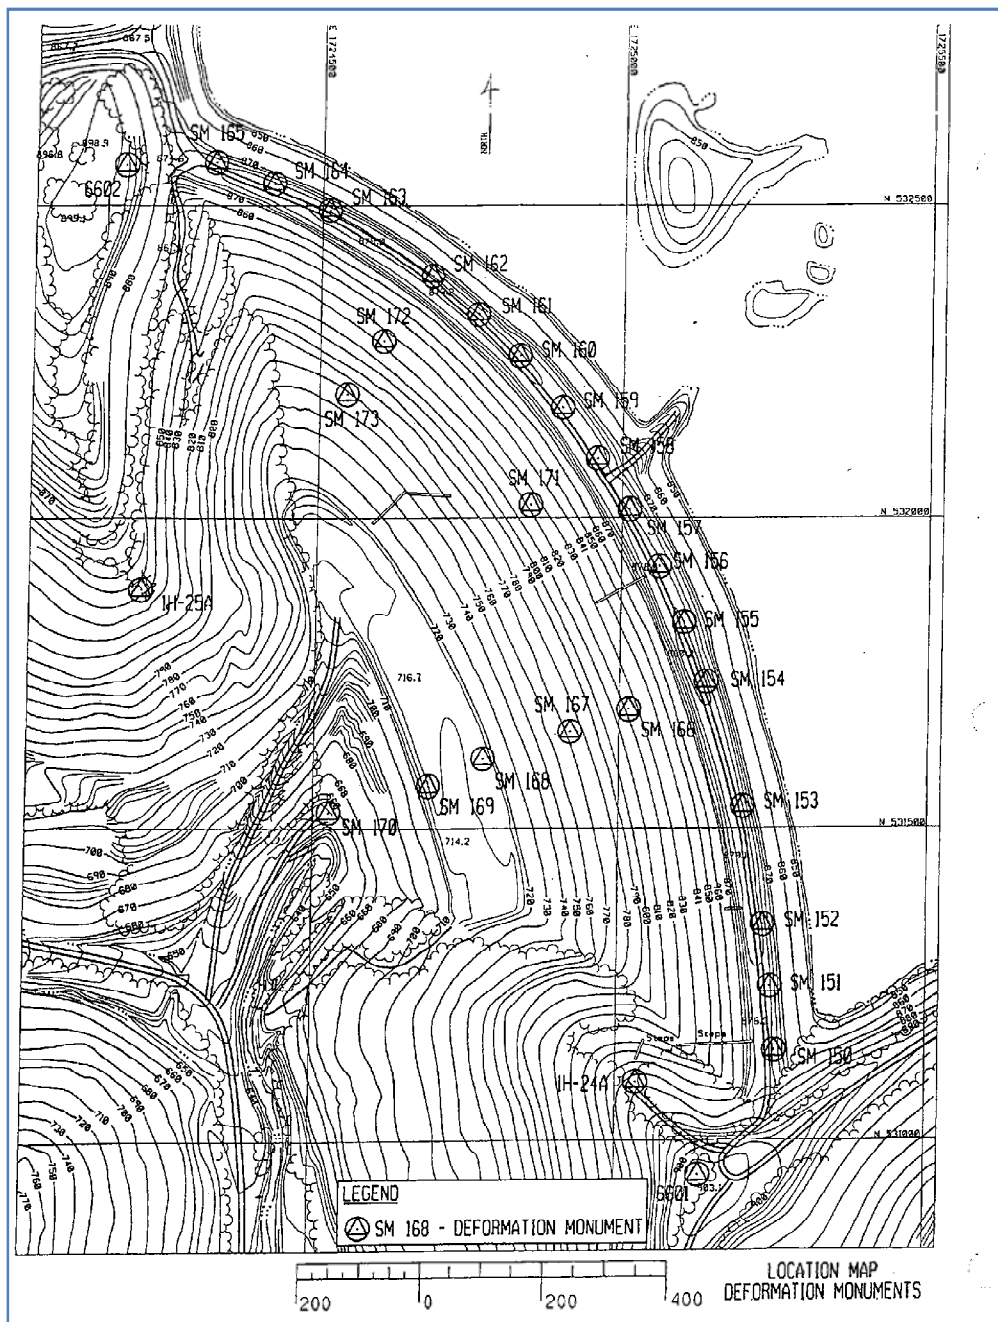
Figure 9.2.1-2. Location Map of Deformation Monuments.

Deformation measurements are performed using dual frequency Global Positioning System (GPS) Methods. Vertical deformation is measured using GPS Methods. Deformation Monuments are shown in Figure 9.2.1-2.

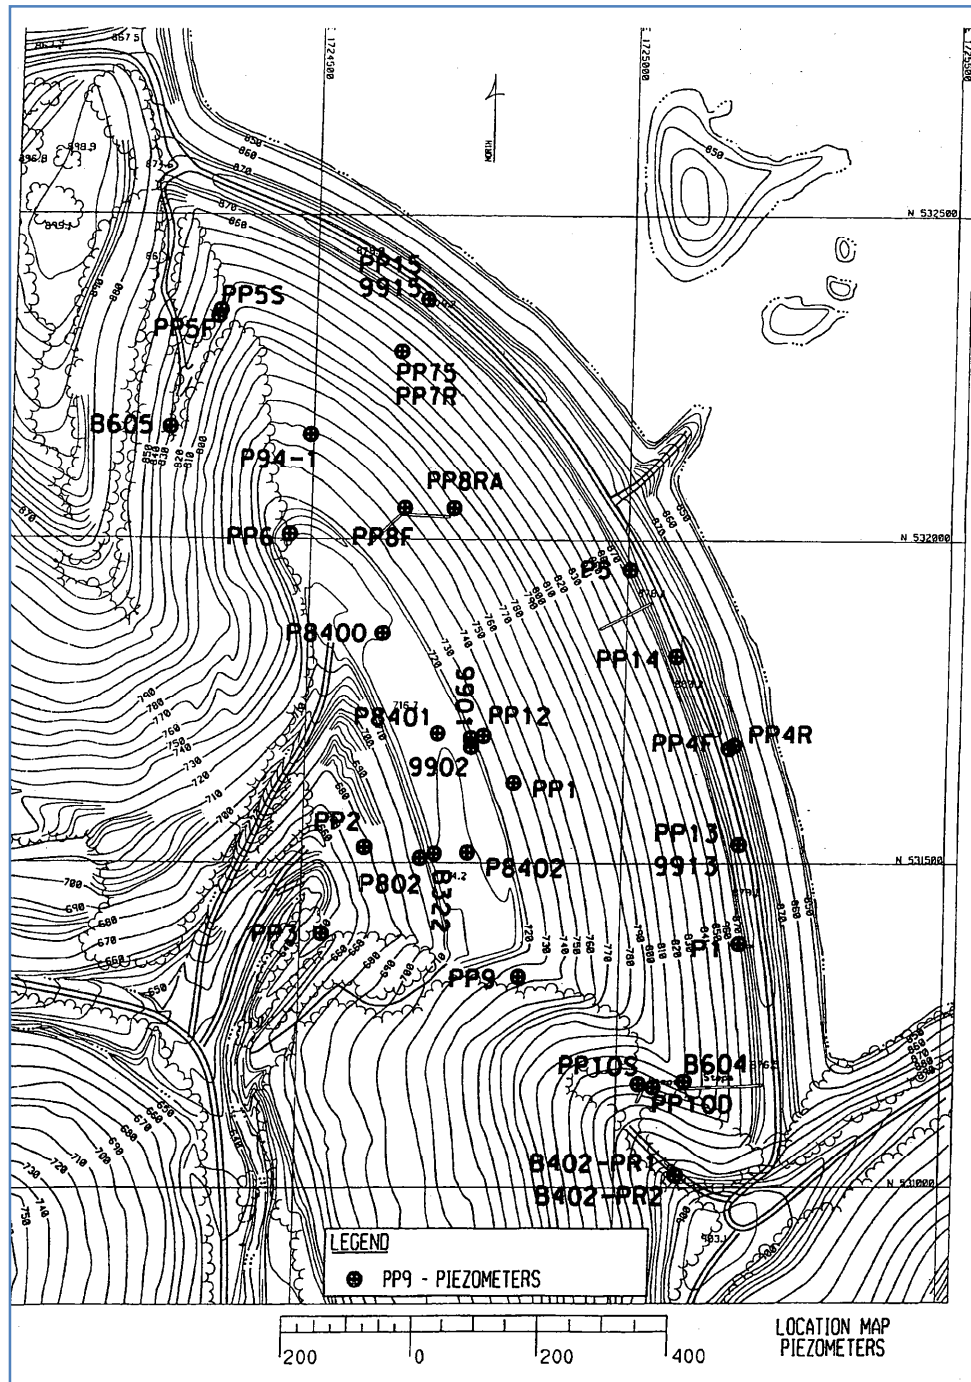
Figure 9.2.1-3. Location Map of Piezometers.

Piezometer readings are obtained monthly for eleven piezometers and quarterly for the remaining 26 by John Amos personnel using a battery powered Sinco water level indicator. Figure 9.2.1-3 is the location map of the piezometers.

The data reviewed identified two long-term seepage areas on the downstream face of the dam. One of the seeps is near the left groin at about elevation 750. This seepage area is referenced as near piezometer P94-1. The second seep is near the right groin at about elevation 740. Both seeps are monitored monthly for flow rates and clarity.
